Subject: **April 2012 Compliance Evaluation Inspection**

**CWA COMPLIANCE EVALUATION INSPECTION REPORT
U.S. ENVIRONMENTAL PROTECTION AGENCY, REGION 5**

L'Anse Warden Electric Company
Fuel Aggregation Facility
17696 U.S. Highway 41
L'Anse, Michigan 49946
46.749590, -88.462230

April 26 –April 27, 2012

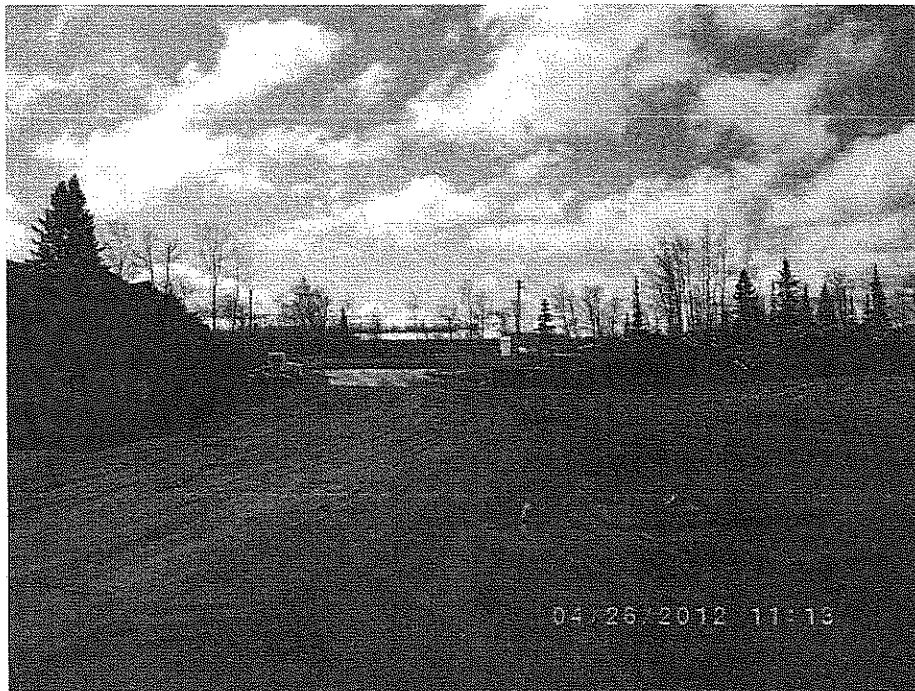
I observed that the entrance, from U.S. Highway 41, into the FAF was dirt inside of the entrance gate (IMGP9069).

Photo: IMGP9069: Entrance to the FAF with the PCP treated railroad ties on the left side of the photo.
Direction: Facing south.

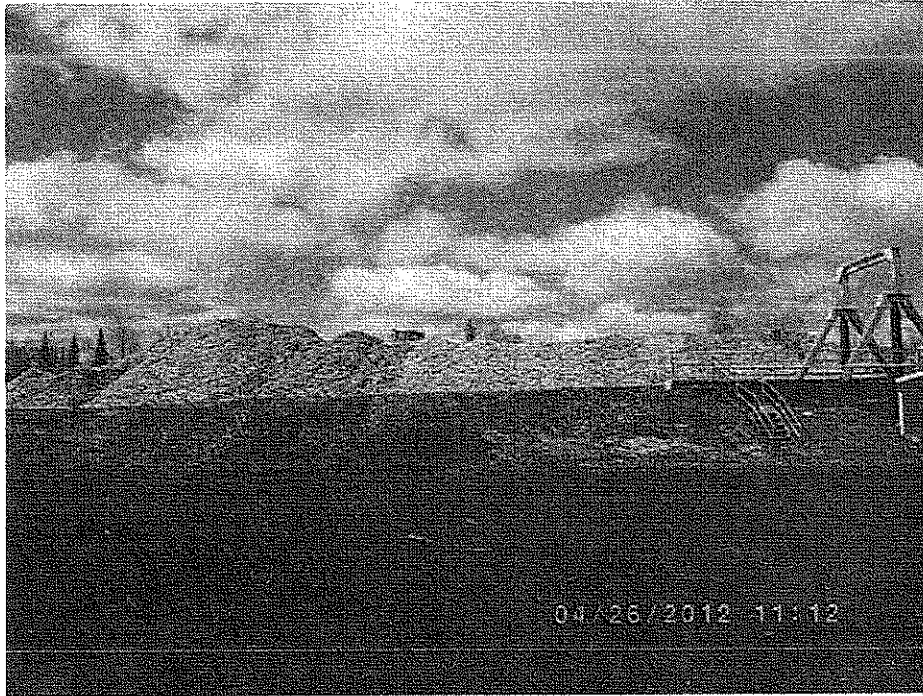
Entering the FAF I observed a large accumulation of wood chips located northwest of the entrance. On the east side of the wood chip pile was a truck scale (Photo IMGP9068).

Photo IMGP9068: Untreated wood chip pile with truck scale.
Direction: Facing west.

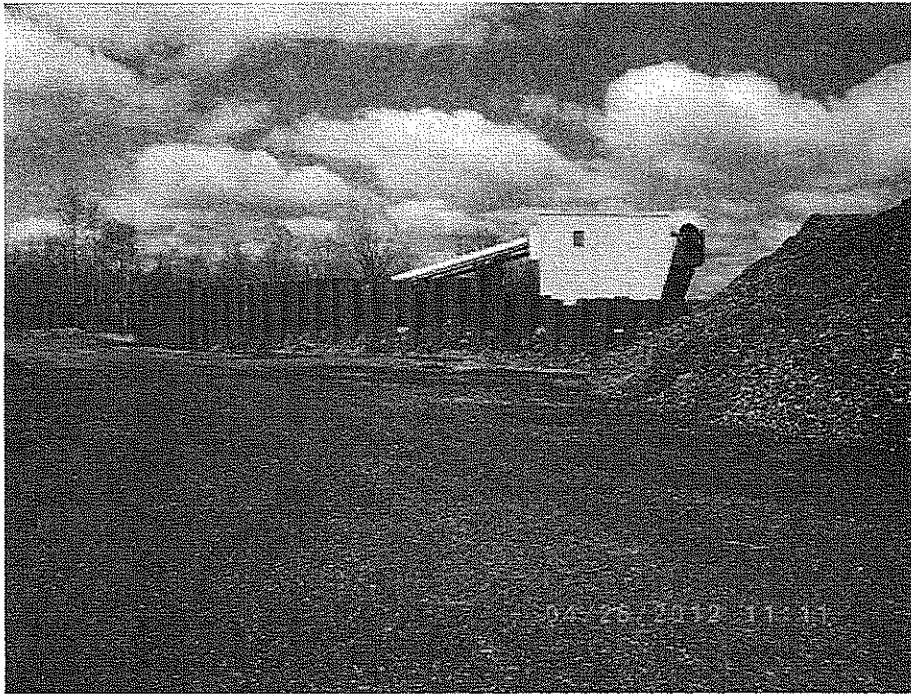
Surrounding the north and northwest sides of the wood chip pile were steel pilings which were separated from the wood chip pile by a dirt road for vehicles and equipment (Photo IMGP9066). I observed piles of wood chips that were pushed up against both sides of the pilings. Wood chips were piled to the top of the pilings in some areas. There was no runoff or water observed during the inspection around the wood chip pile, the dirt road or pilings.

Photo IMGP9066: Pilings along the north side of the access road surrounding the wood chip pile.
Direction: Facing northwest.

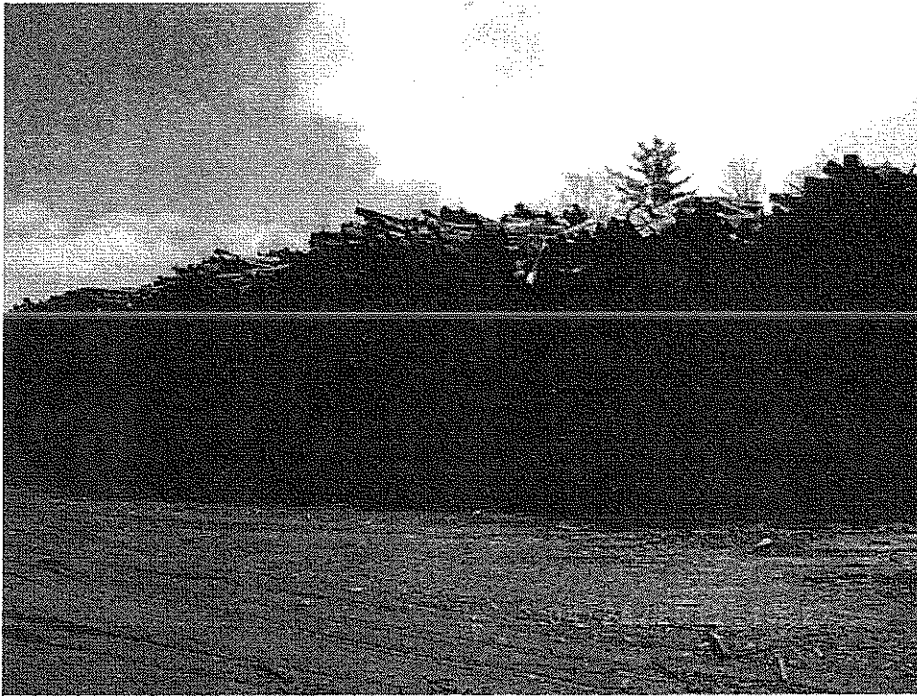
There were three separate areas where railroad ties were aggregated. Upon entry from U.S. Highway 41, I observed a large aggregate of railroad ties that ran parallel to the east side of the entry road (Photo IMGP9045, IMGP9062 and IMGP9081). This was identified by facility representatives as the PCP treated railroad tie aggregate. I observed that the ties were piled on the ground. They were not elevated. I observed that immediately to the east, and running parallel with the PCP railroad tie aggregate, was a ditch that had water during the inspection (Photo IMGP9080). The water in the ditch flowed on site from a culvert that ran under U.S. Highway 41 just east of the FAF entrance (Photo IMGP9078). The ditch had thick vegetation and water was not flowing from the north end of the ditch during the inspection (Photo IMGP9064). At the north end of the PCP railroad tie aggregate was another ditch that ran from west to east (Photo IMGP9063). This ditch received runoff from the woods between the PCP railroad ties and the overflow railroad tie pile. This ditch was full of debris. I observed water in the ditch at the time of the inspection, but it was not flowing. The only observable method of discharge from the ditch was from overflow at the west end, just north of the PCP railroad ties. Facility representatives stated that any overflow from this point would flow towards the north end of the FAF through an open dirt area and would dissipate. No structural controls were observed around the PCP railroad tie aggregate.

Photo IMGP9045: PCP treated railroad tie aggregate.
Direction: Facing northeast.

In order to mitigate pollutants from entering the nearby stream, it is recommended that structural controls, such as berms and silt fencing, should be placed along the west side of the facility around railroad tie piles. BMPs should be implemented around the site to prevent storm water or run-on from off site from contacting sources of potential pollutants such as the railroad tie aggregates.

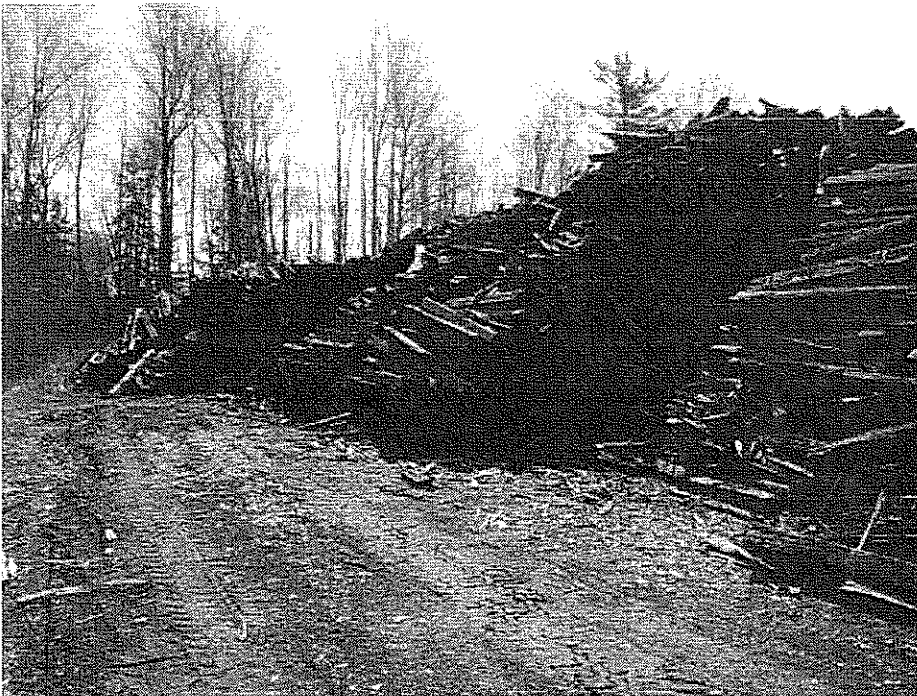
Photo IMGP9062: North end of the PCP railroad tie aggregate.
Direction: Facing east.

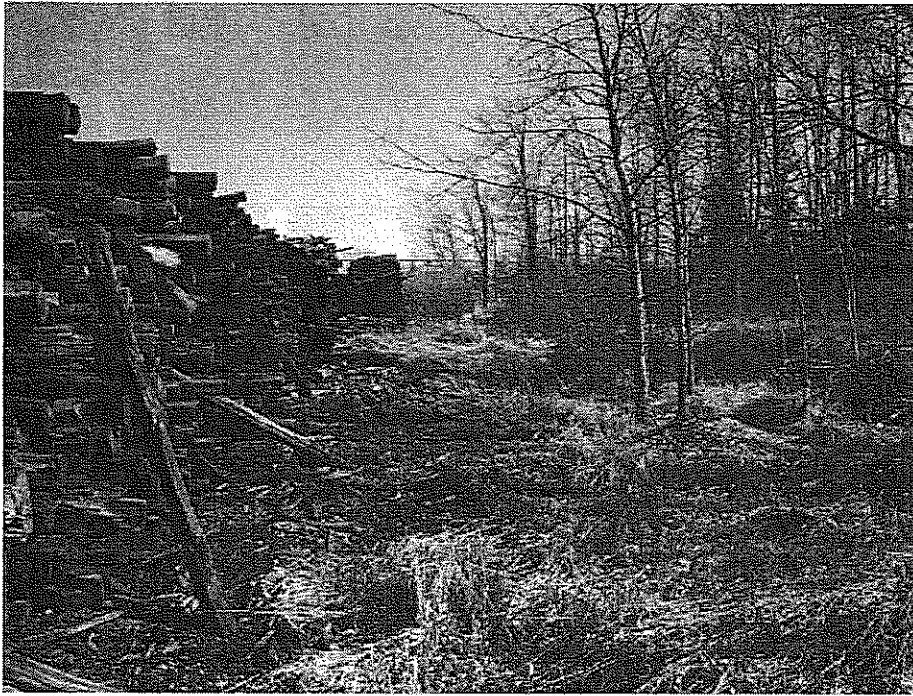
Photo IMG9081: Eastern edge of the PCP railroad tie aggregate with the adjacent ditch containing water.
Direction: Facing north.

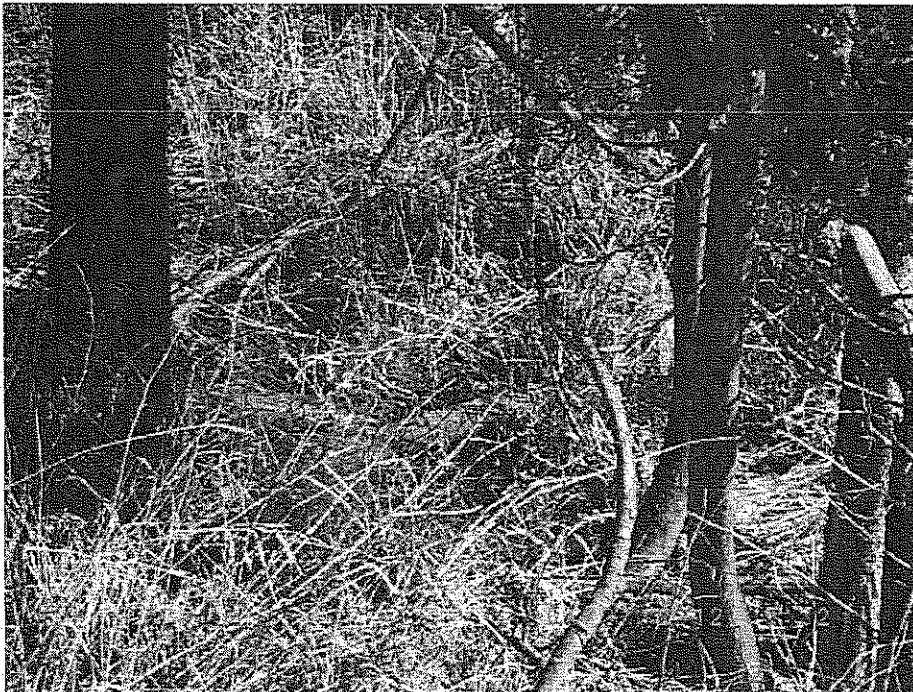
Photo IMG9080: Water in the ditch on the eastern edge of the PCP railroad tie aggregate.
Direction: Facing north.

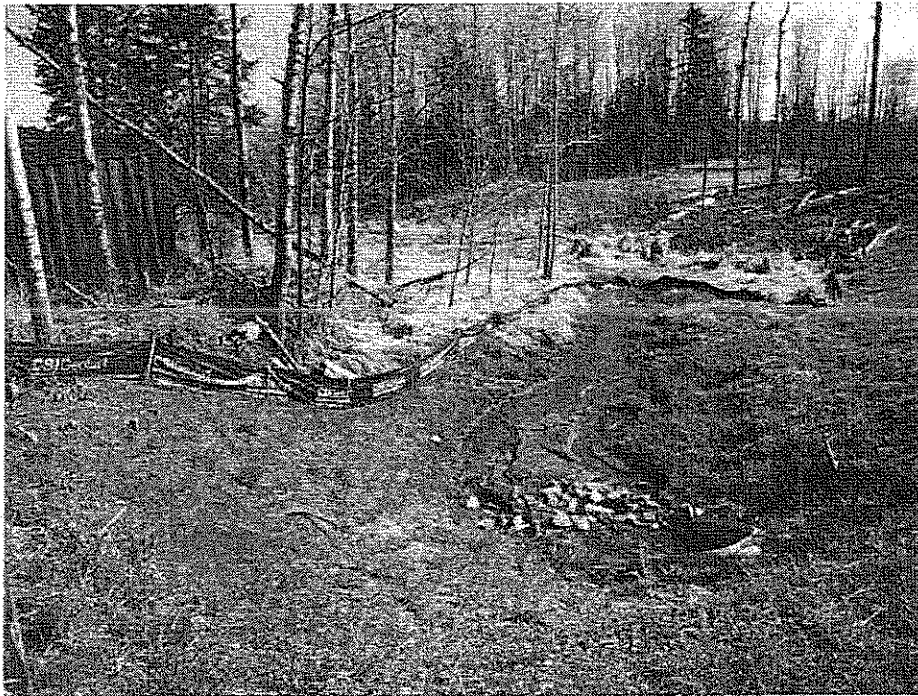
Photo IMGP9078: Culvert from under U.S. Highway 41 flowing onto the FAF.
Direction: Facing northeast.

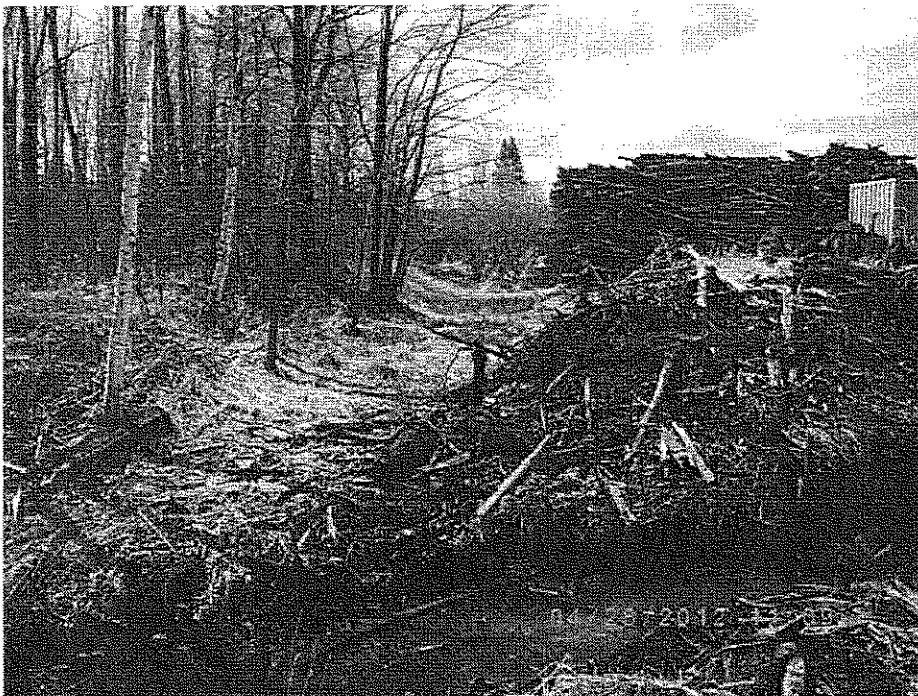
Photo IMGP9064: Ditch adjacent to the PCP railroad tie aggregate leading into a second ditch with water at the north end of the aggregate.
Direction: Facing south.

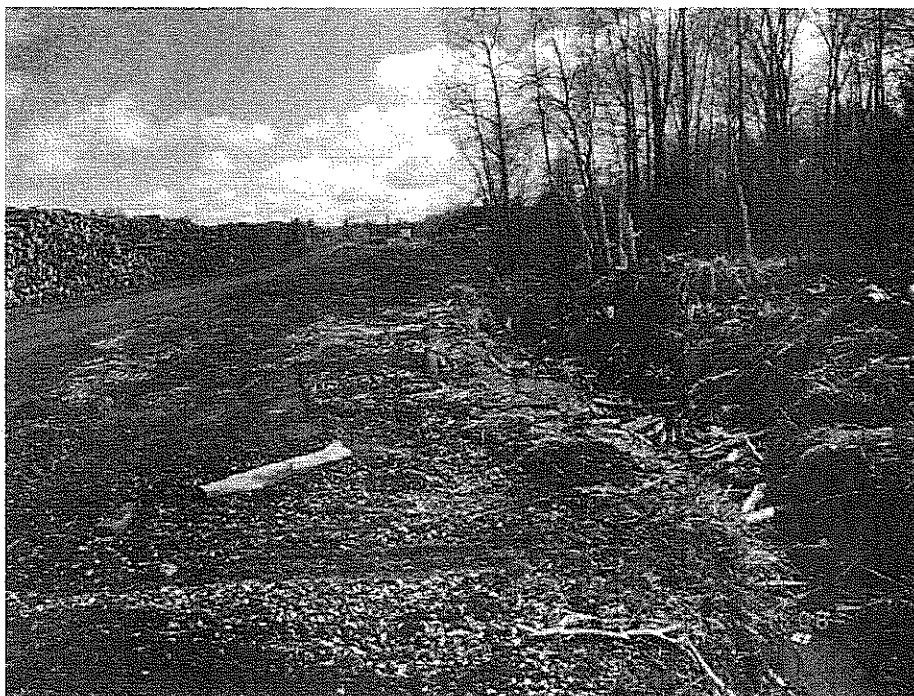
Photo IMGP9063: Ditch at the north end of the PCP aggregate with water and debris present.
Direction: Facing east.

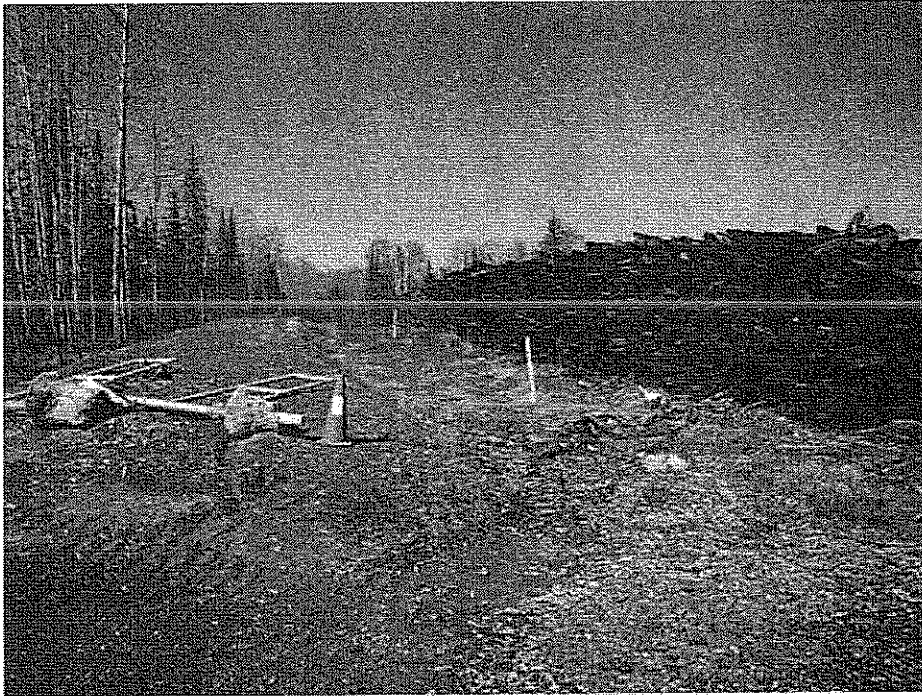
On the west side of the entry road running parallel to U.S. Highway 41 was a second railroad tie aggregate identified by facility representatives as being creosote treated railroad ties. This aggregate was not elevated off of the soil. I observed a berm along the south side of the creosote aggregate (Photo IMGP9085). The berm started at the FAF entrance and was approximately 150 feet in length. The berm did not extend the length of the aggregate. Immediately west of where the berm ended, I observed an area that showed evidence of water flowing into the creosote aggregate (Photo IMGP9086). I observed that this area had water at the time of the inspection. The west end of the creosote railroad tie aggregate was piled to the edge of the woods (Photo IMGP9087). I identified a small north flowing stream that ran along the west edge of the FAF that was approximately 30 to 40 feet from the west end of the creosote aggregate (Photo IMGP9089). The ground in the woods was vegetated between the creosote railroad ties and the stream. I observed a runoff path into the woods from the area around the creosote aggregate. I did not observe a distinct connection between the pathway and the stream. There was water in the pathway at the time of the inspection. The berm was the only structural control identified around the creosote aggregate during the inspection.

Photo IMGP9085: Creosote railroad tie aggregate with a berm running parallel on the south side.
Direction: Facing west.

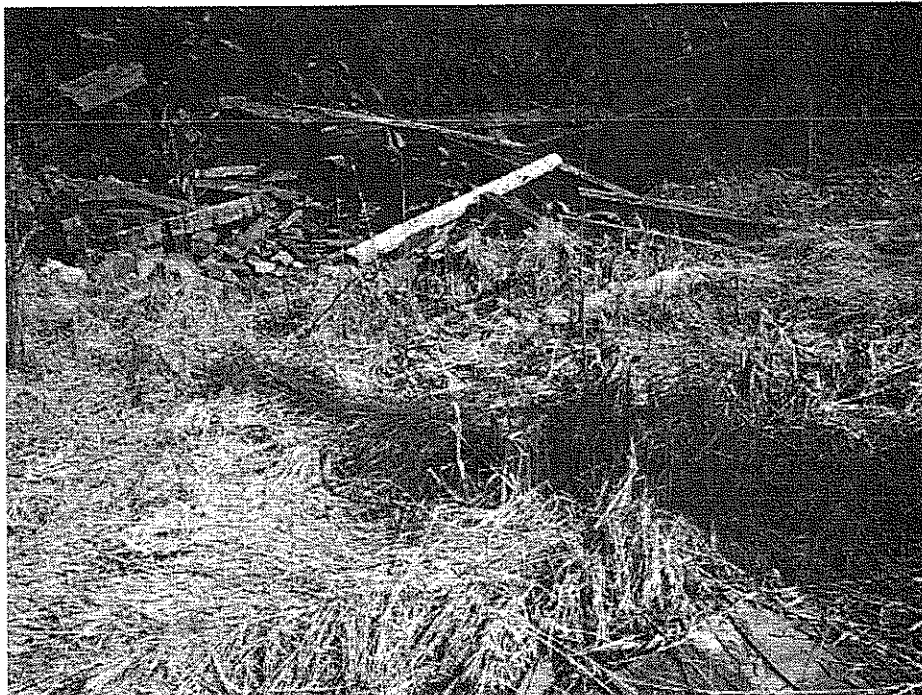
Photo IMGP9086: Wet area on the south side of the creosote railroad tie aggregate that showed evidence of flow under the aggregate.
Direction: Facing north.

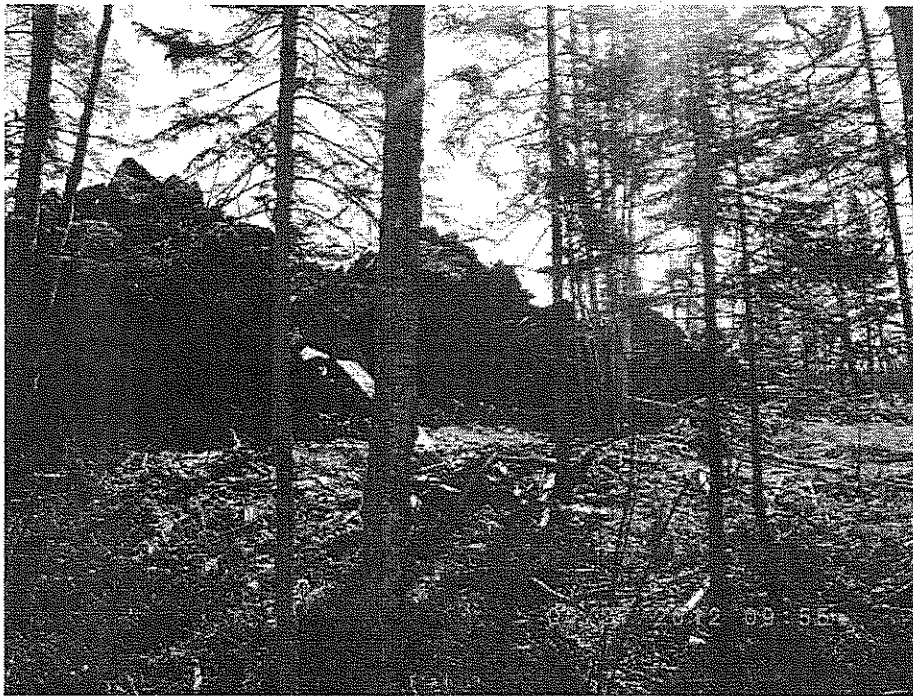
Photo IMGP9087: West end of creosote railroad aggregate adjacent to the woods.
Direction: Facing southeast.

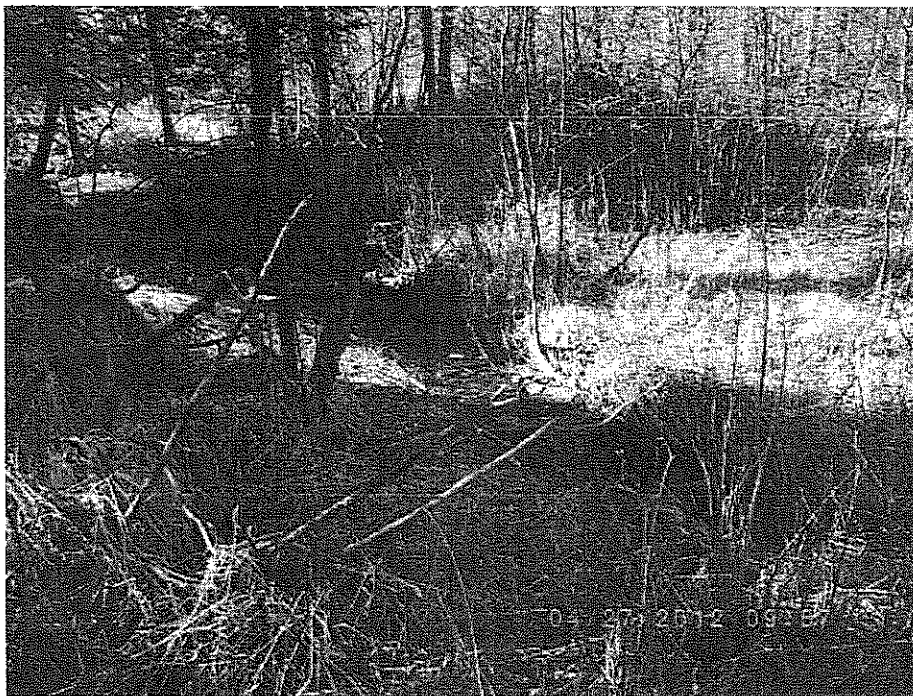
Photo IMGP9089: Stream running along the western edge of the FAF.
Direction: Facing southwest.

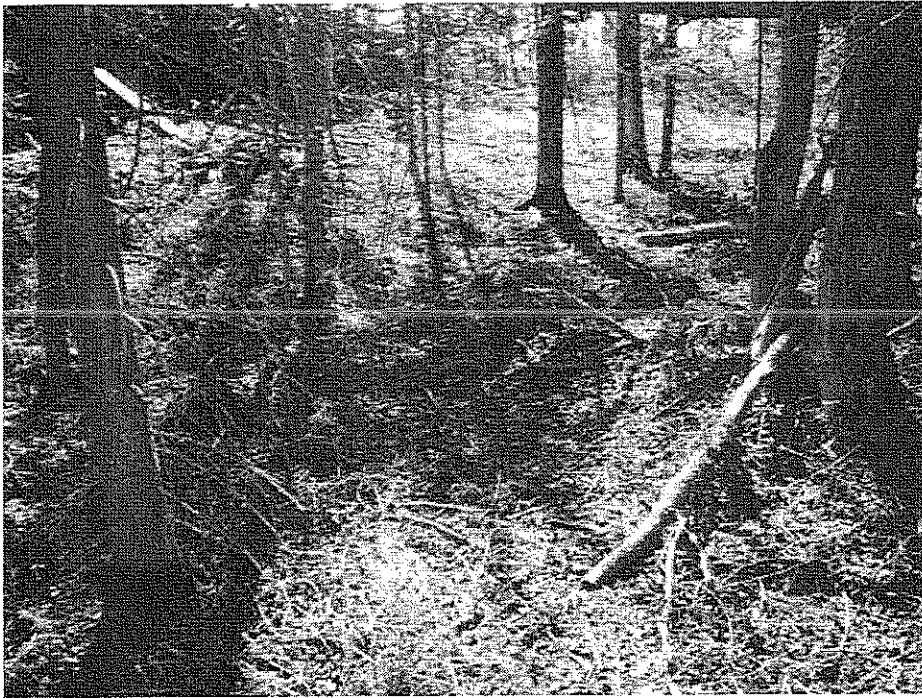
Photo IMGP9088: Runoff pathway from the area around the end of the creosote railroad tie aggregate into the woods and towards the stream along the west edge of the FAF.
Direction: Facing southeast.

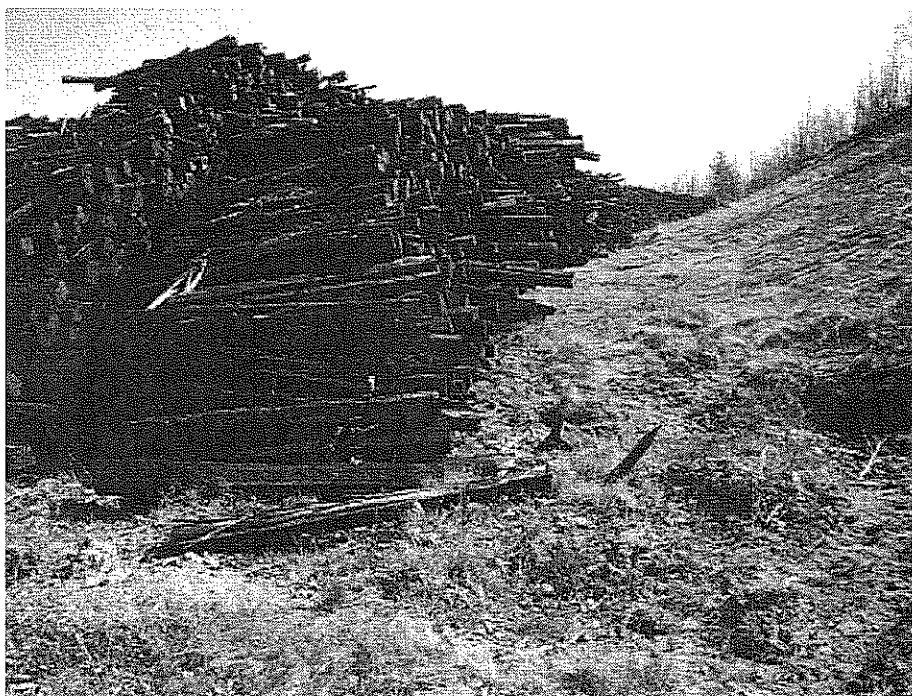
The third aggregate was termed the overflow railroad tie aggregate. All railroad ties in the overflow aggregate were creosote treated. The overflow aggregate ran parallel to U.S. Highway 41 just south of the Verso wood storage area. The aggregate was not elevated off of the soil. The overflow aggregate was situated at the base of a hill and ran parallel to U.S. Highway 41 (Photo IMGP9082). The hill was vegetated and ran the length of the overflow aggregate, turning slightly north at the east end of the overflow aggregate (Photo IMGP9061). The ground at the west end of the overflow aggregate was sloped west towards the woods. No water or pathways were observed around the overflow aggregate. There were no structural controls identified around the overflow aggregate.

Photo IMGP9082: View from the west end along the south side of the overflow railroad tie aggregate.
Direction: Facing northeast.

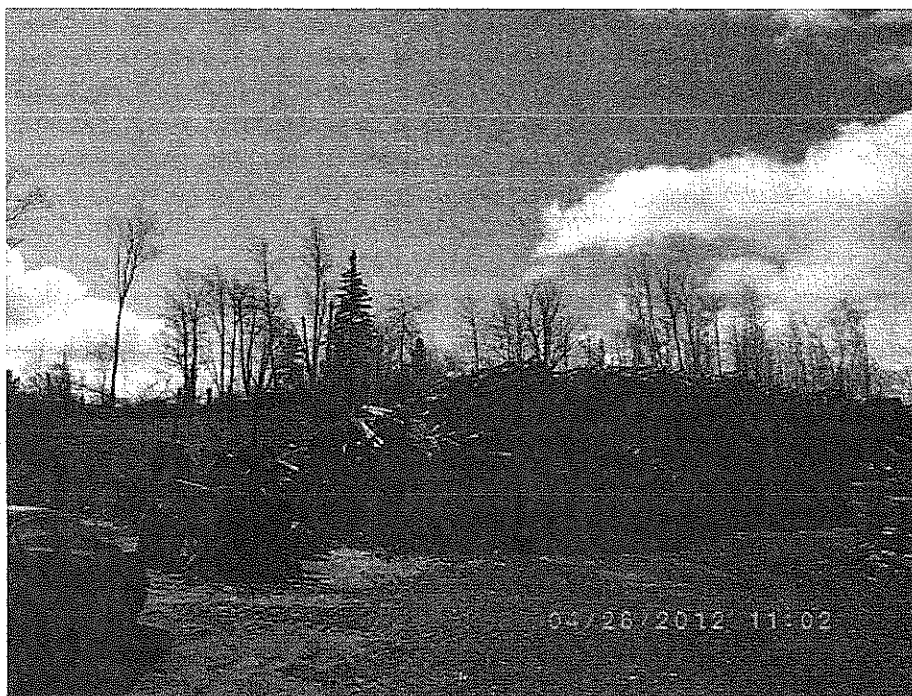
Photo IMGP9061: East end of the overflow railroad tie aggregate.
Direction: Facing south.

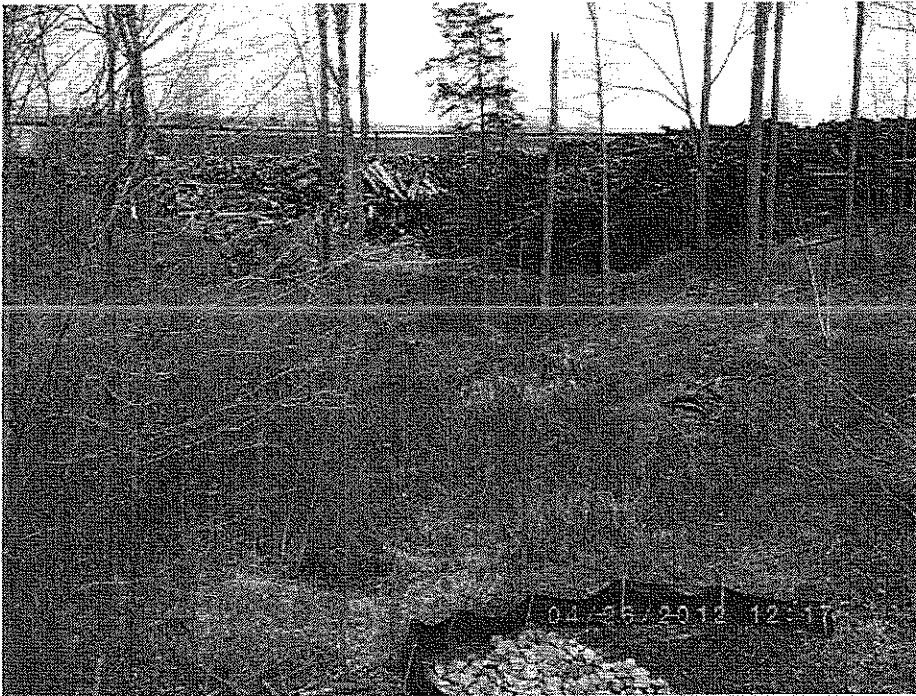
Photo IMGP9077: Overflow railroad tie aggregate from U.S. Highway 41.
Direction: Facing northeast.

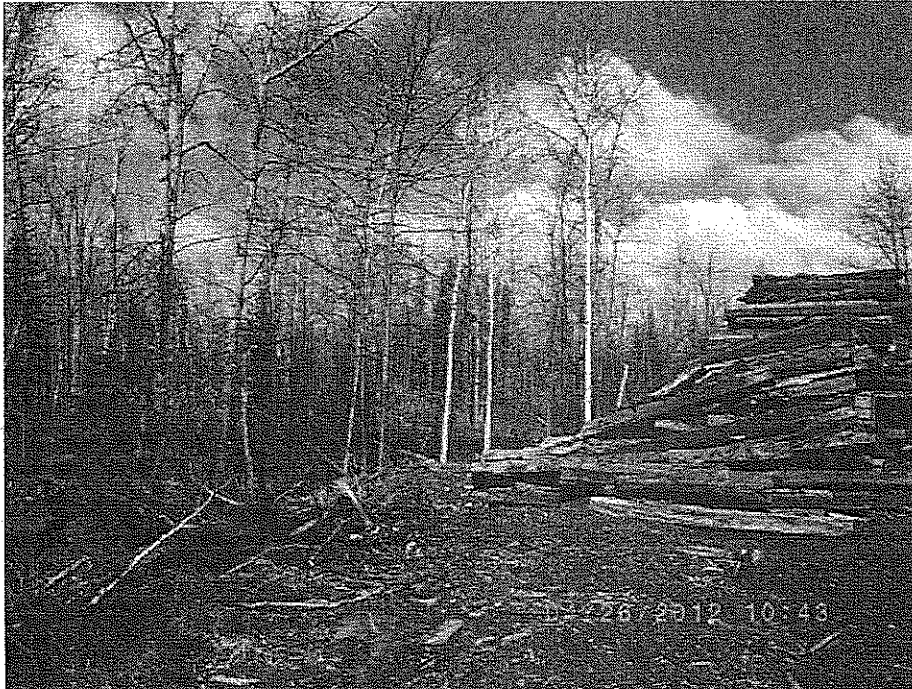
I observed an additional small pile of railroad ties at the west end of the FAF along the edge of the woods (Photo IMGP9053 and IMGP9052). The railroad ties were located on the west of the construction area behind the processed railroad tie storage area. Facility representatives identified the railroad ties as those that needed to have metal removed. The length of time that the railroad ties sat at this location is unknown, but appeared significant based on the dirt buildup at the base of the pile (Photo IMGP9052). I observed that the railroad ties were located within 20 feet of the stream that ran along the west edge of the FAF. The area between the railroad ties and the stream was vegetated and contained debris. No structural controls were observed around the railroad ties.

Photo IMGP9053: Additional pile of railroad ties located west of the processed railroad tie storage building.
Direction: Facing northwest.

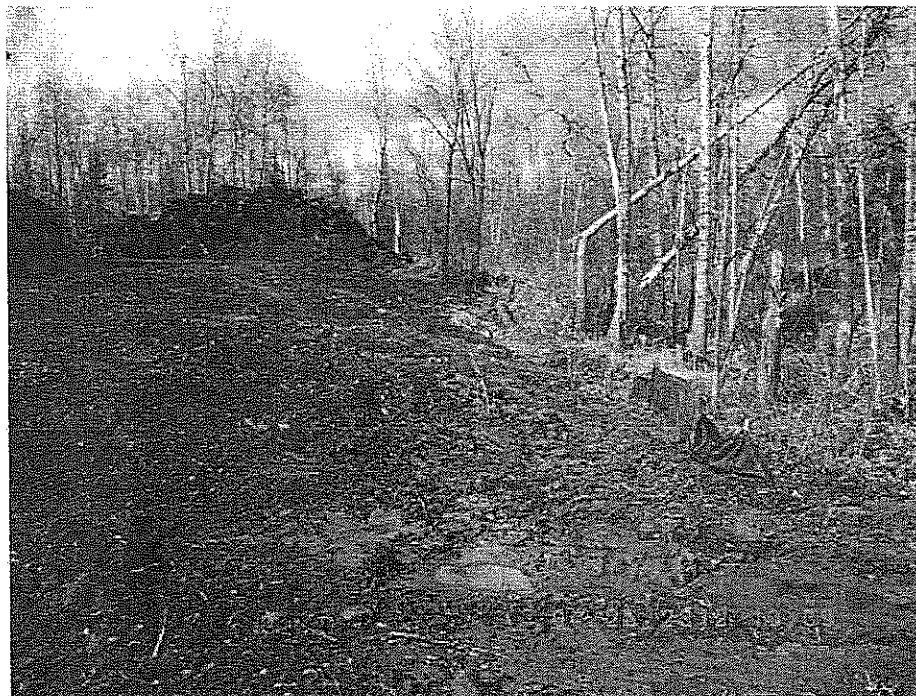
Photo IMGP9052: Loose soil located at the construction area along the west side of the processed railroad tie storage building.
Direction: Facing west.

I observed that the construction area around the processed railroad tie storage building was not stabilized in accordance with the NPDES general permit for discharges from construction activity (Photo IMGP9052). This was most apparent on the north and west sides. The area contained loose dirt and no vegetation. Water was pooled in several areas of the uneven soil at the time of the inspection (Photo IMGP9052). Along the north edge of the construction area there was a ditch that contained water at the time of the inspection. The water in the ditch was not flowing (Photo IMGP9050 and IMGP9049). There was silt fencing on the sides of the ditch. I observed that the ditch led to the small stream that runs along the western end of the FAF. The ditch was vegetated and contained significant debris including fallen trees and branches (Photo IMGP9049). I observed silt fencing along the north side and at the northwest corner of the construction area. The silt fencing was not continuous. Facility representatives stated that the silt fencing was put up for the construction work and was never removed. The silt fencing that remained had not been properly maintained and contained areas of both torn and fallen fence (Photo IMGP9050). In some areas, there were gaps underneath the fence. I observed a pile of dirt and rock that contained eroded runoff pathways that led into the woods towards the small stream on the west side of the FAF (Photo IMGP9054). The pile was located on the west side of the processed railroad tie storage building. Large rocks and dirt from the pile were observed in the woods within 10 feet of the small stream. There were no structural controls observed around the area.

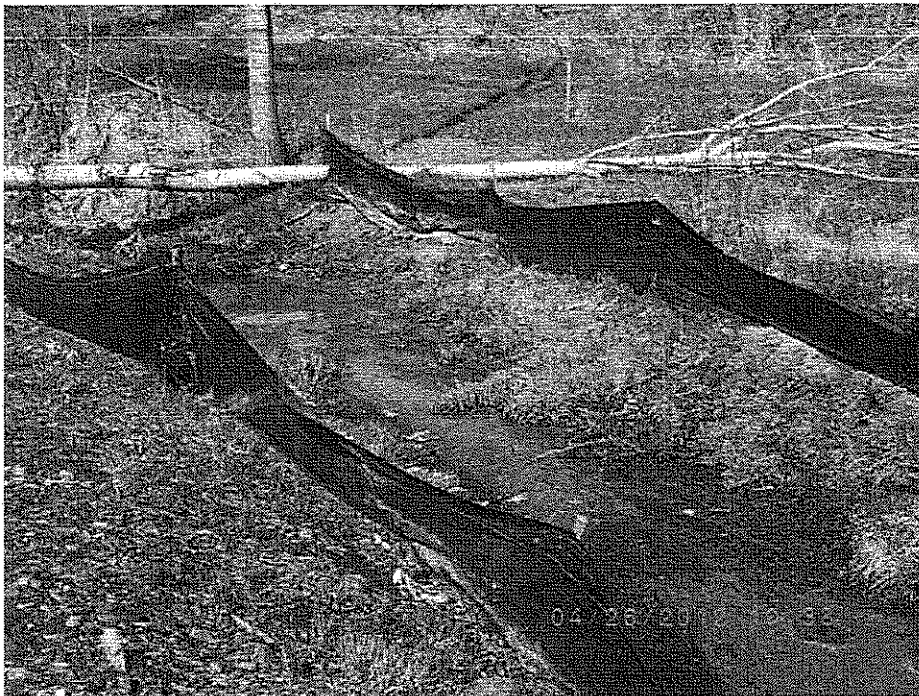
Photo IMGP9050: Silt fencing along the ditch at the north end of the construction area.
Direction: Facing northwest.

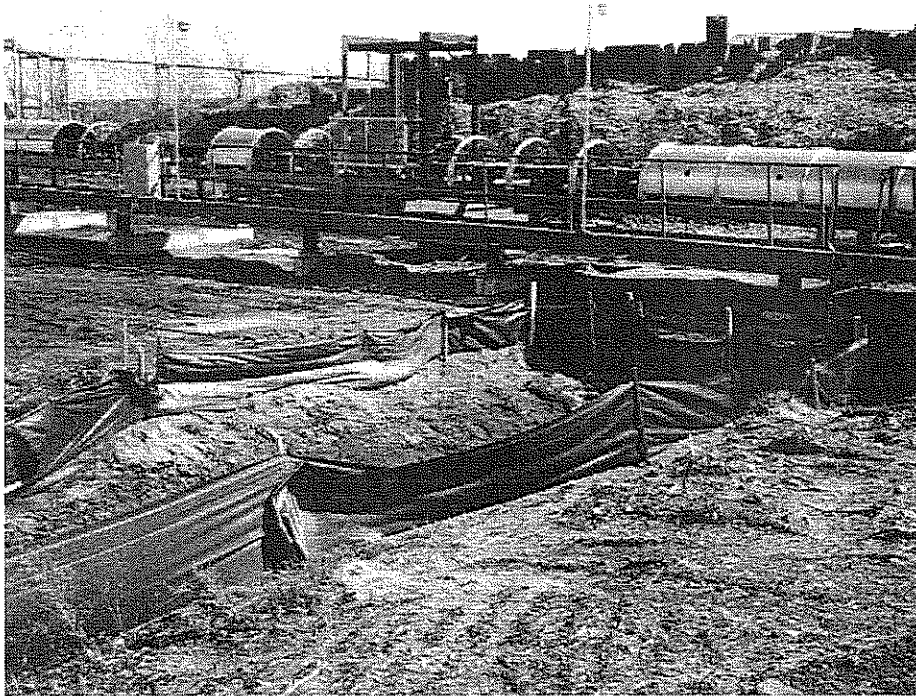
Photo IMGP9049: Silt fencing around the ditch at the north end of the construction area with identifiable rips and missing segments.
Direction: Facing northeast.

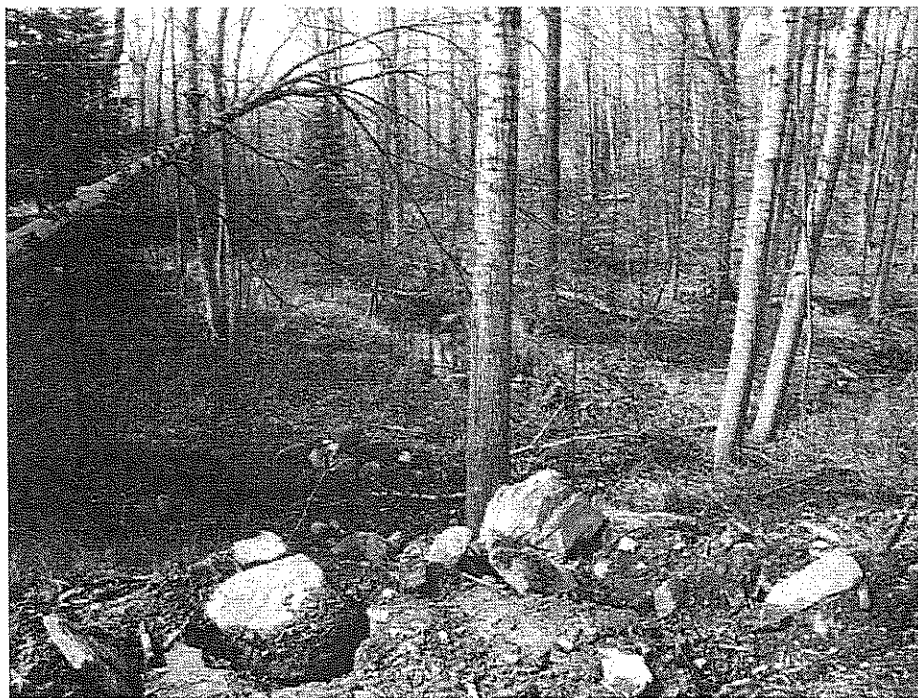
Photo IMGP9054: Soil and rock that was piled along the western side of the construction with identifiable runoff pathways leading towards the stream.
Direction: Facing southwest.

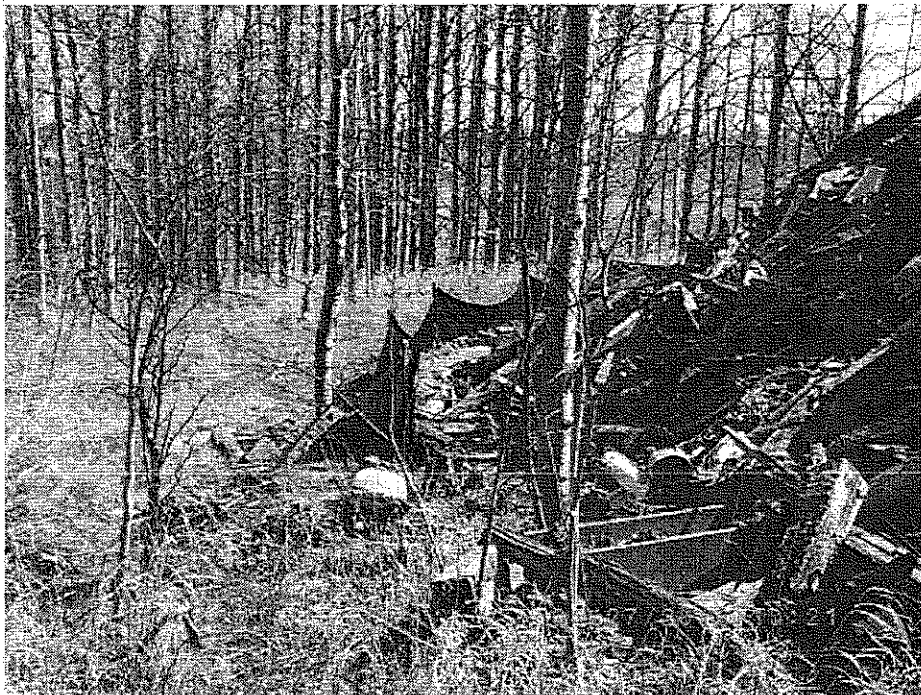
I observed a pile of railroad tie scrap wood pieces and dirt at the northeast corner of the facility where railroad ties are unloaded from the railcars (Photo IMGP9098). Facility representatives identified the pile as material removed from the bottom of railcar after railroad ties have been offloaded. Next to the pile were two uncovered dumpsters (Photo IMGP9097). Railroad tie pieces and soil are loaded into the dumpsters and shipped off site. The current pile was too large to be put into two dumpsters. Facility representatives stated that dumpsters are not picked up frequently enough to only store the material in the two dumpsters. I observed that there was silt fencing along the north side of the pile (Photo IMGP9098). Any runoff from the pile that would leave the FAF would flow through a heavily vegetated wooded area before reaching CertainTeed (Photo IMGP9098). The silt fencing was the only structural control identified.

Photo IMGP9098: Backside of the scrap railroad tie and soil pile with silt fencing around the backside. Direction: Facing northeast.

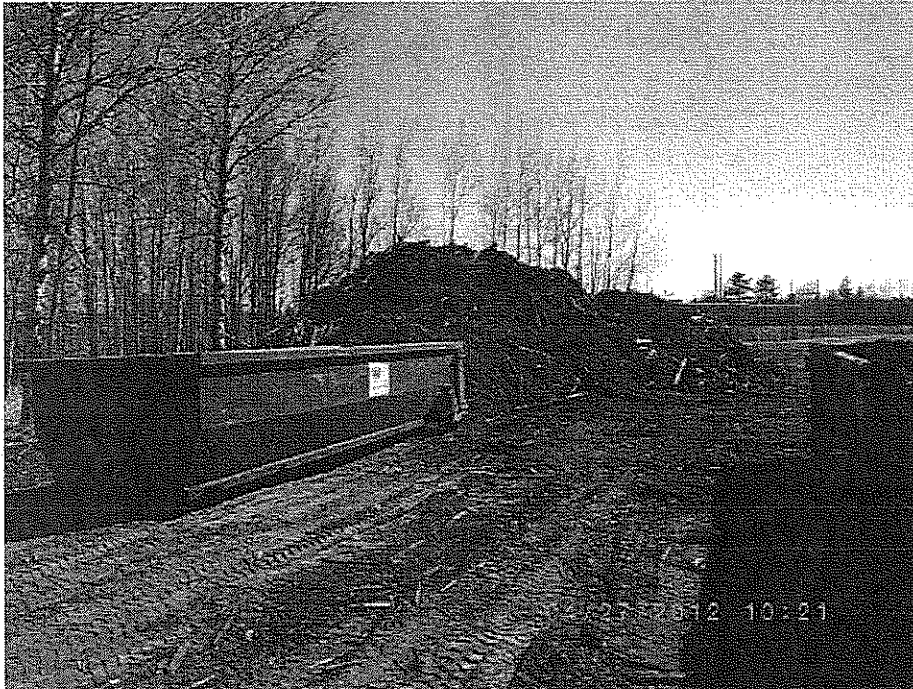
Photo IMGP9097: Dumpsters used to remove the scrap railroad tie and dirt material.
Direction: Facing northeast.

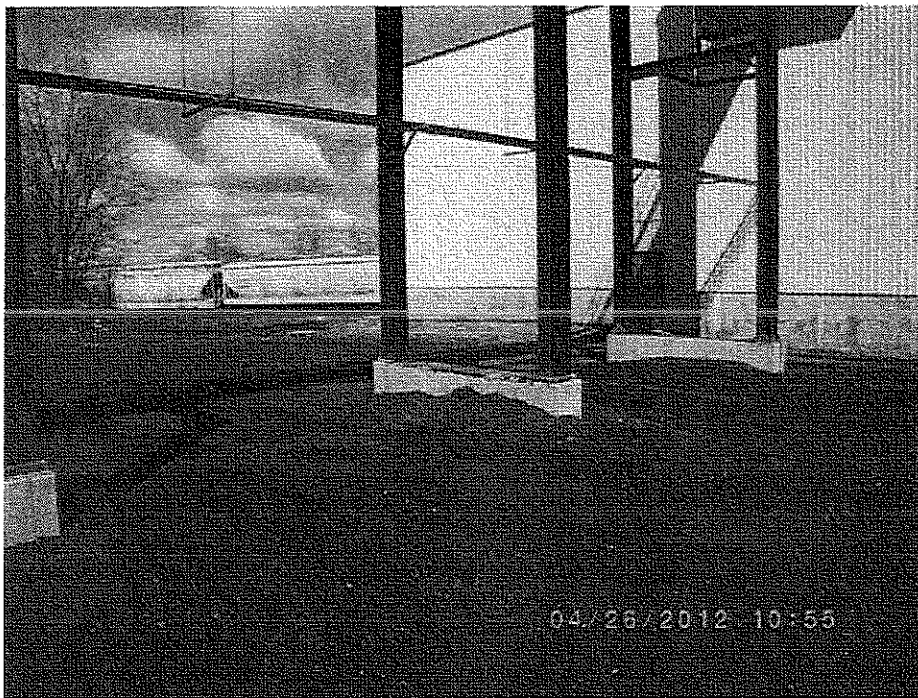
I observed that the conveyor belt to the wood room building is covered, but there was a buildup of fine wood particles underneath the conveyor (Photo IMGP9058). I observed fine wood particles falling from the conveyor. The area below the conveyor was wet. There was a section of silt fencing that remained from previous construction activity that was located next to the conveyor loading bin. There were no other structural controls observed around the wood room building or under the conveyor. I observed a ditch that entered the woods near the the northwest corner of the wood room building (Photo IMGP9094). The ditch was vegetated once it entered the woods (Photo IMGP9095). The ditch led to the stream along the west side of the FAF (Photo IMGP9096). No flow was observed in the ditch during the inspection.

Photo IMGP9058: Wood fines accumulated under the conveyor leading to the wood room building.
Direction: Facing northwest.

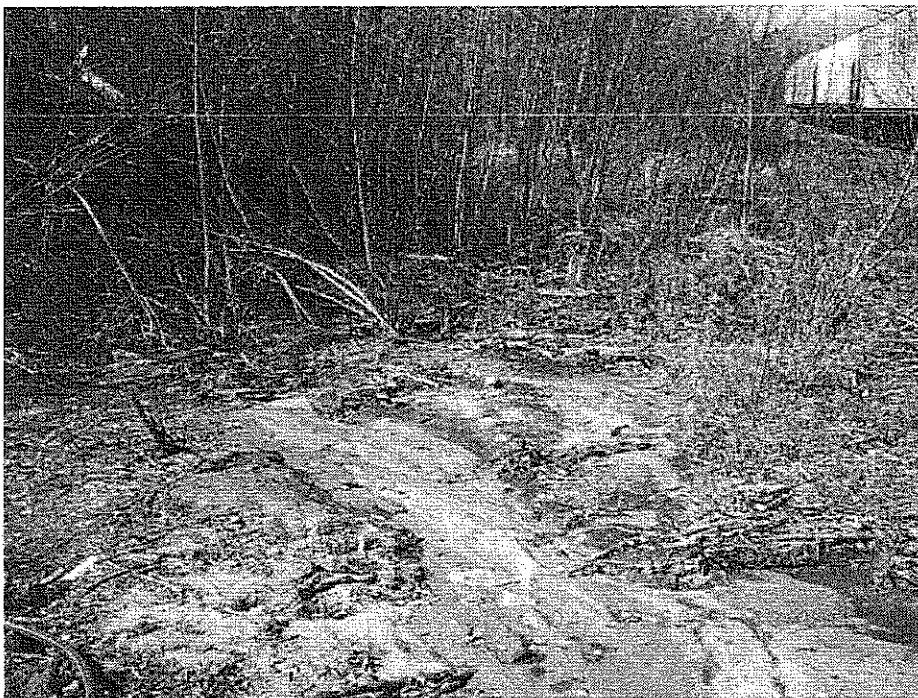
Photo IMGP9094: Discharge pathway into the ditch at the northwest corner of the wood room building.
Direction: Facing west.

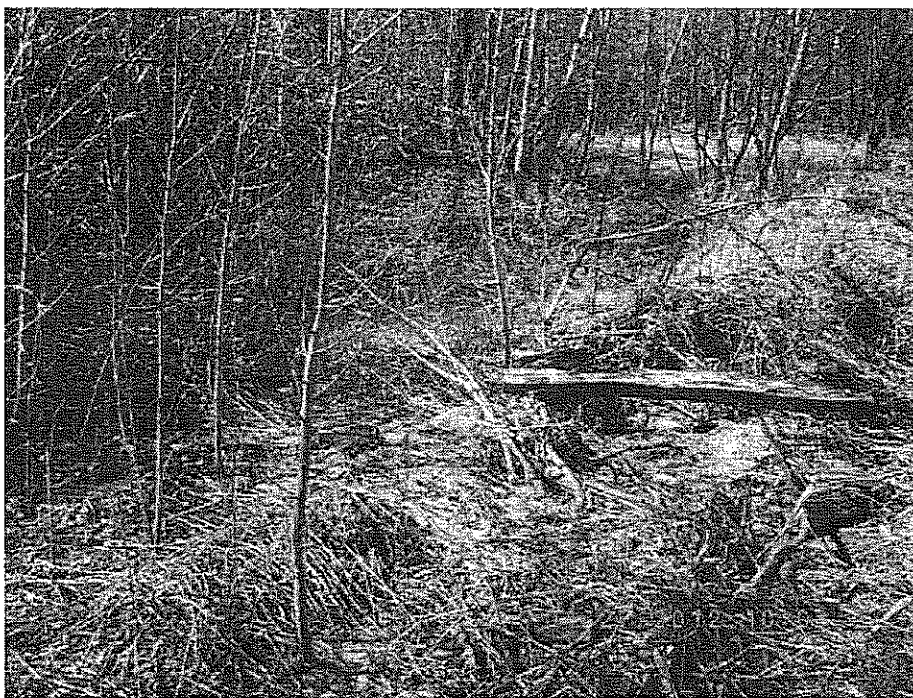
Photo IMGP9095: Vegetated area of the ditch originating at the northwest corner of the wood room building.
Direction: Facing west.

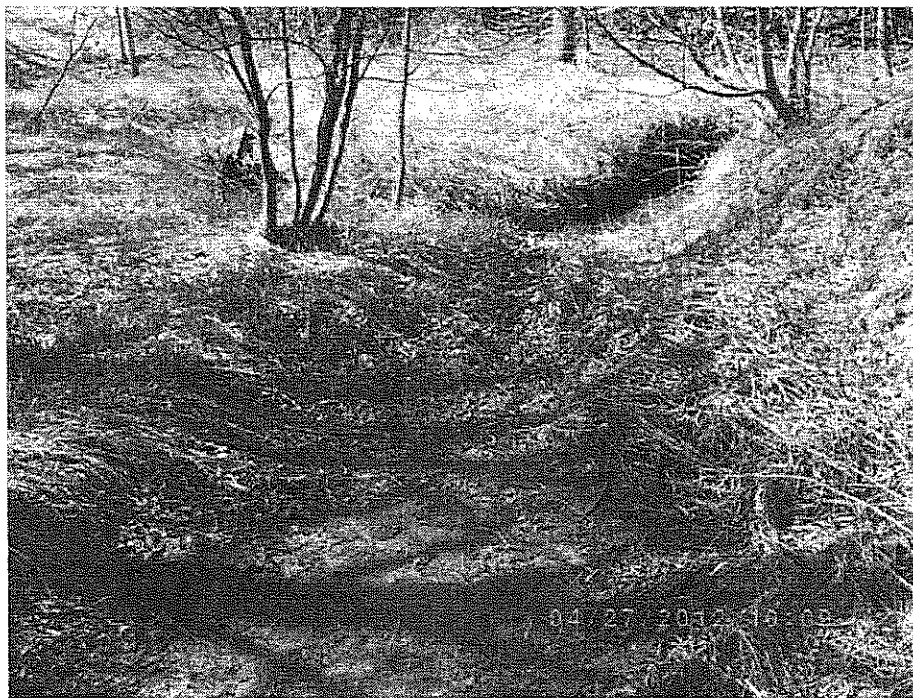
Photo IMGP9096: Discharge point from the ditch into the stream along the west edge of the FAF.
Direction: Facing southwest.

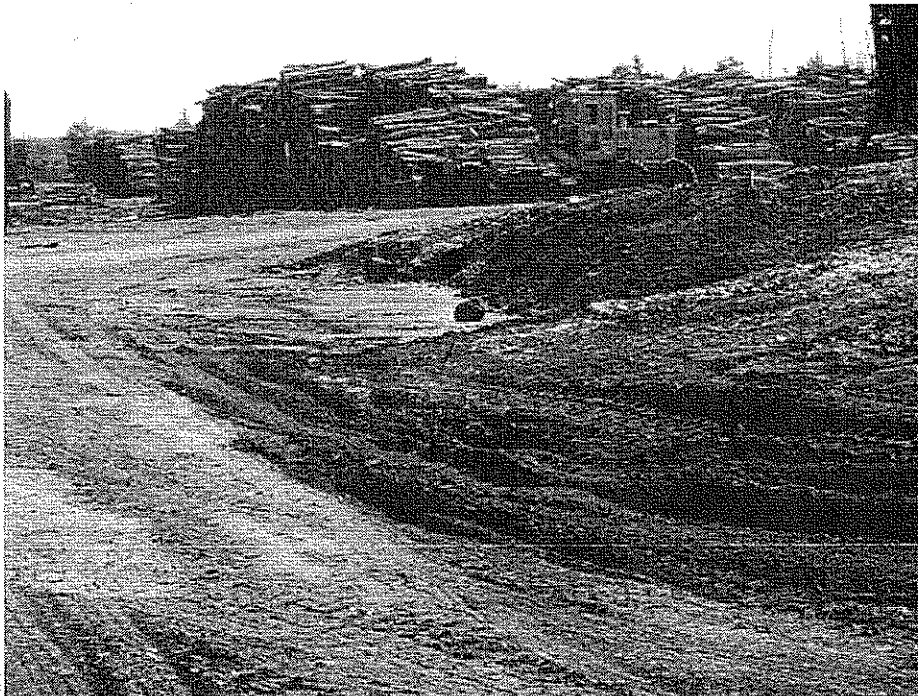
Photo IMGP9092: Culvert from the Verso wood storage area.
Direction: Facing east.
